Subject: **Erosion and Water Quality Analysis of Lassing Park**

Erosion and Water Quality Analysis of Lassing Park

Prepared for City of St. Petersburg, FL
April 9, 2021

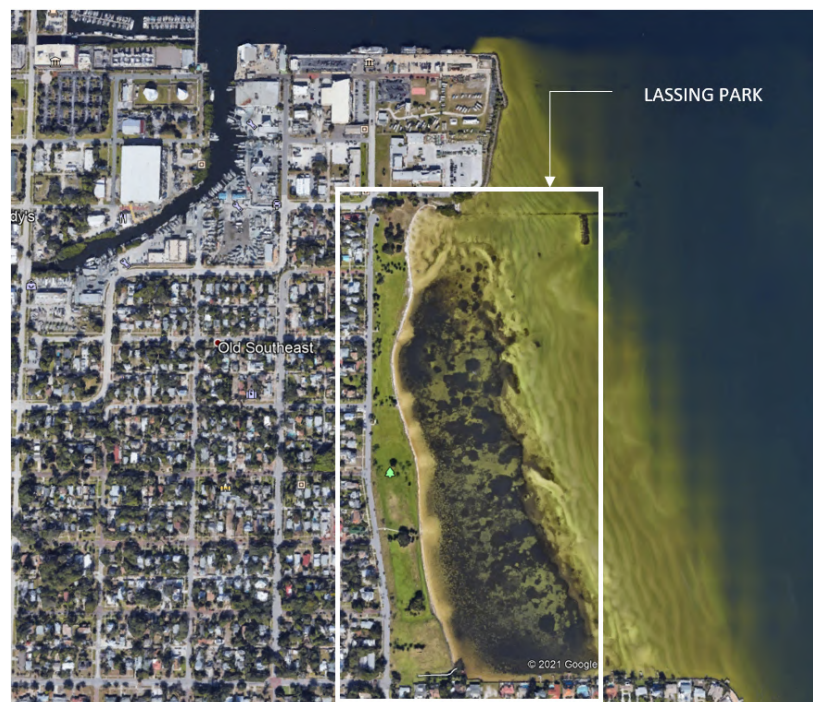
Figure 1. Lassing Park Aerial of Site Location

Figure 1 is an aerial view of Lassing Park and as seen from the Google Earth image, the park has a seagrass bed, grassy recreational area, and dredged sand bordering a deep channel that leads to Tampa Bay. The north end of the park borders a U.S. Federal Army Reserve Center. To the west and south of the park are the Old Southeast and Tropical Shores communities, respectively.

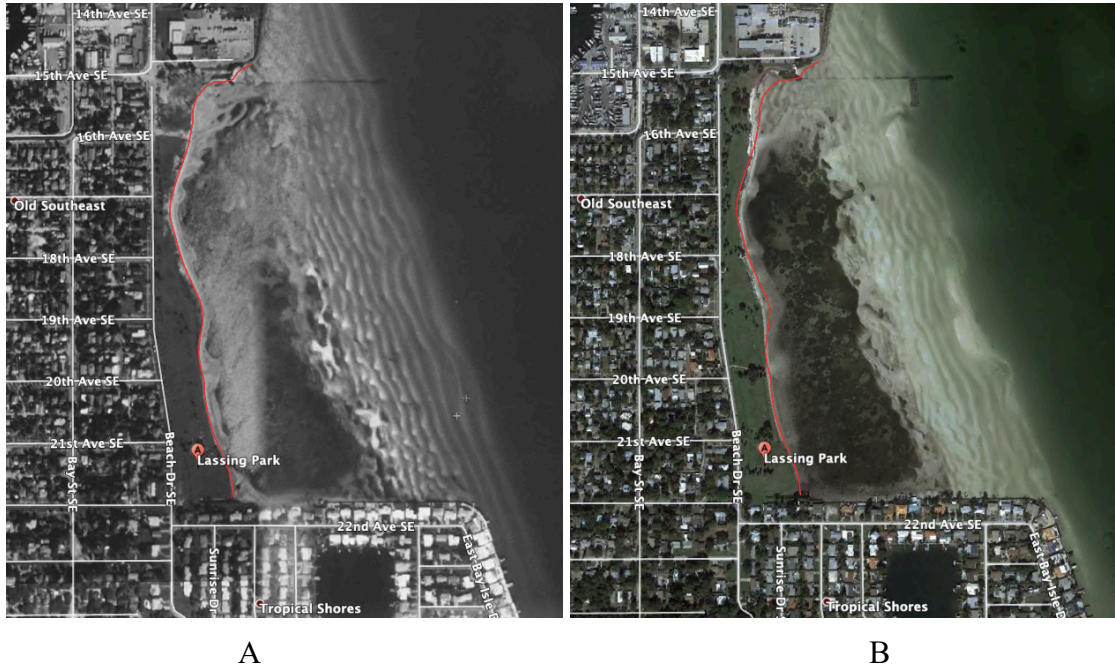
Figure 2. Google Earth Capture of Total Erosion at Lassing Park 1994 (A) & 2020 (B)

Lassing Park is a tide dominated beach, meaning the surf zone extends longer than usual and the nearshore zone is steep after the bar. Since 1994, Lassing Park's shoreline has receded approximately 20,000 ft². In June 2012, Tropical Storm Debby hit Florida's west coast and increased the erosion of Lassing Park, especially at the north end of the park. The overall erosion of Lassing Park from 1994 to 2020 can be seen in Figure 2, and the erosion of the north end can be seen in Figure 3.

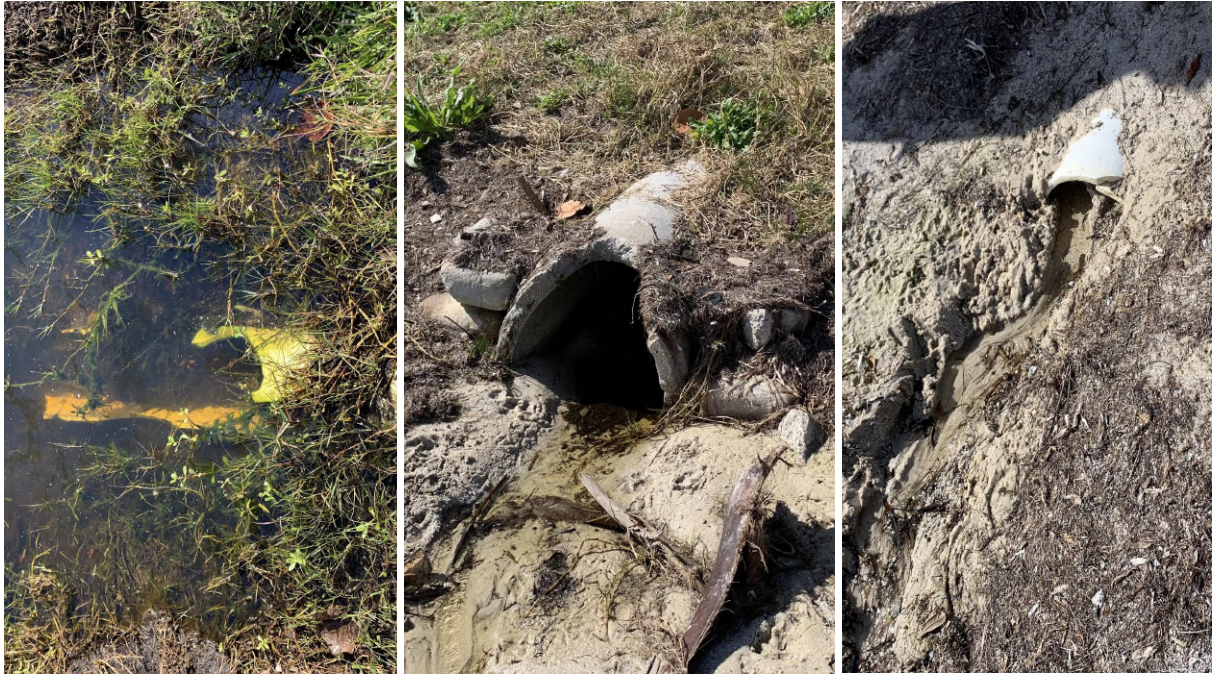
Figure 4. Existing Stormwater Piping in Poor Condition

The stormwater structures throughout Lassing Park are in need of significant repair. Many of the PVC stormwater pipes are broken and some are almost completely buried by the sand, causing slow discharge flows. The concrete pipes present dangers because of broken pieces and exposed rebar (Figure 4).

Concrete endwalls protect the ends of pipes. Since most of the pipes at Lassing Park are broken on the ends, this is a needed solution. Concrete endwalls can be incorporated into the naturally occurring hill as much as possible so that it will not take away from the natural aesthetics of the shoreline or present unnecessary hazards. The plan view in Appendix A models the concrete endwalls that Aqua Engineering suggests being implemented.

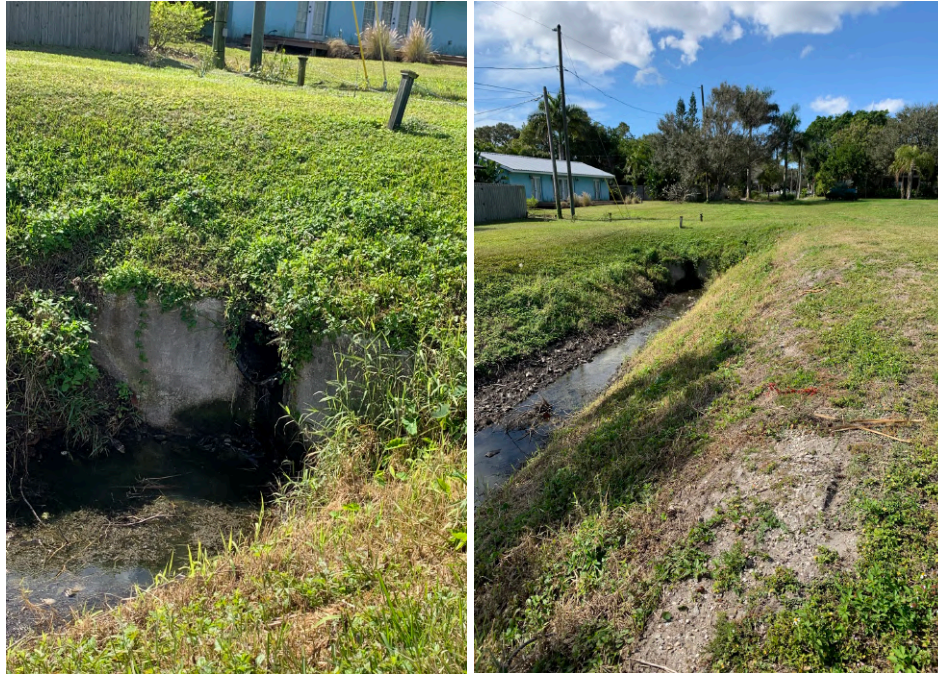
Figure 5. Existing Stormwater Ditch at South End in Poor Condition

A 180-foot-long ditch is located at the south end of the park borders the backyards of residential properties of Tropical Shores (Figure 5). An underground pipe with an inner diameter of approximately 12 inches discharges directly into the open ditch. At the time of the site visit, this contained pipe flowing water, but there had been no significant rain in the preceding days. The last precipitation event occurred 3 days prior to the site visit and lasted 2 hours. The constant water flow observed could be produced due to groundwater infiltration or illicit wastewater connections from members of the community. Although there was constant flow from the pipe, the water in the ditch remained stagnant and produced a noticeable odor. This poor drainage could be caused by improper grading of the ditch. While the original design of the ditch may have had a proper slope, this slope has been flattened to nearly zero over time. This is most likely caused by erosion of the base of the ditch. The base of the drainage outlet appears to have signs of where the original height of the soil was, but this has since significantly dropped, as shown in Figure 5. Additionally, this stormwater outflow was found to have a layer of grease on the water. The stagnant water, low flow speeds, decomposition of organic matter, noticeable odor, and unusual color all are indicators of poor water quality.

Vegetated swales are considered low-impact development alternatives (Figure 14). They are shallow channels that are used to convey runoff, facilitate infiltration, and reduce nutrient loading into receiving water bodies (Acomb and Clark, 2008). They are an alternative to traditional conduits that rely primarily on pipes and gutters. During the site visit, the ditch at the south end of the park, adjacent to the backyards of several residents, was found to have stagnant water that was producing an odor. By re-grading the ditch and introducing vegetation, effluent

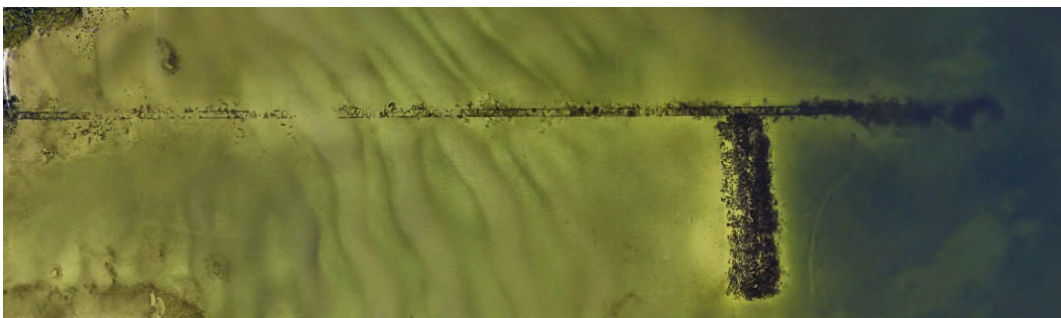
Figure 6. Google Earth Capture of Old Pier Rubble at North End of Lassing Park

The surf zone at Lassing Park extends longer than usual and the nearshore zone is steep after the bar. Google Earth images demonstrate that a substantial amount of sediment is available on the north side of the park, above an old pier (Figure 6). The presumption that this structure may have been a pier was confirmed by Michael Perry, a City of St. Petersburg Engineer who was interviewed during the initial site visit (Figure 7). The team consulted with Dr. Cheryl Hapke, a Marine Science Professor at the University of South Florida (USF) with a PhD in Coastal Geology, who has studied the Lassing Park shoreline. Based on two discussions with Dr. Hapke, it was determined that longshore drift carries sediment from north to south at the park. The presence of rubble from the old pier shows a high likelihood of inhibiting this natural sediment transport. Removing a portion of the old pier rubble may facilitate future sediment transport by longshore drift and replenish the park at the north end where the effects of scour have become the most evident.

Approximately 2,340 ft² of excavation and removal of the old pier rubble would need to occur. The depth of the foundation is unknown, making it hard to approximate the extent of the demolition that would be required to extract the remaining concrete. The removal could prove to be quite costly due to the fact that the rubble is in the water and partially covered by sand. However, the extraction could prove to be a bit easier if the work was scheduled to take place during low tide events. A cost analysis revealed that the project could be completed for about \$90,000.

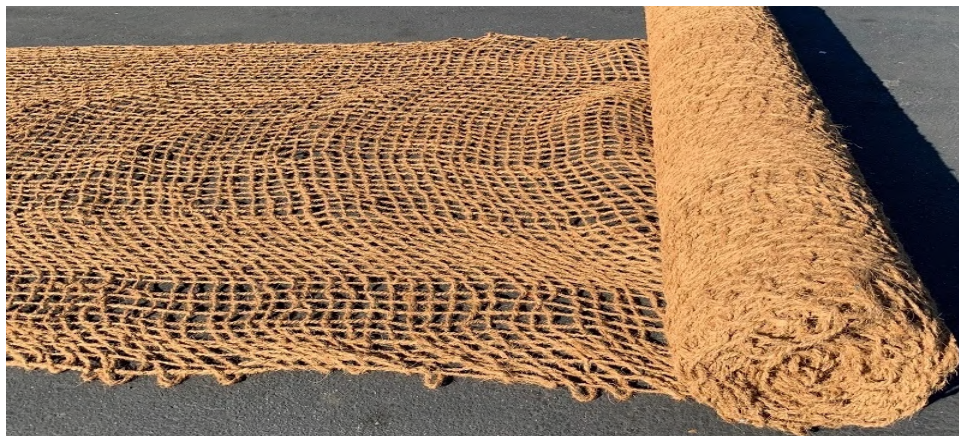
Figure 8. Biodegradable Coir Geotextile Turf Reinforcement Mat (Sandbaggy)

Geotextiles can consist of natural fibers such as coir (coconut straw), or can be formed from more durable synthetic fibers, most commonly polypropylene. Woven geotextiles are more durable but are less capable than their nonwoven counterparts at facilitating drainage.

For the implementation of geotextiles at Lassing Park, there are a few important factors to consider. The lining that will sit on the flat part of the beach needs to be thin and secure, so as to not present a tripping hazard for beach goers. The material should be durable enough to withstand walkers, pets, and wave energy. A longer effective life will make the alternative more cost effective and minimize the need for routine upkeep or replacement. For aesthetic purposes, the geotextile should be sand-colored so that it blends well with the existing beach and is concealed as much as possible. For geotextile sandbags, they must have the durability and drainage capacity that the flat liner possesses, but also be resistant to tractive forces to maintain stability in the event that humans or wave energies dislodge them. Mangroves added at the park must be planted at an appropriate depth for their roots to take hold and for them to be able to absorb necessary nutrients for them to thrive. Using AutoCAD, a plan and profile view was modeled for this alternative and is included in Appendix A.

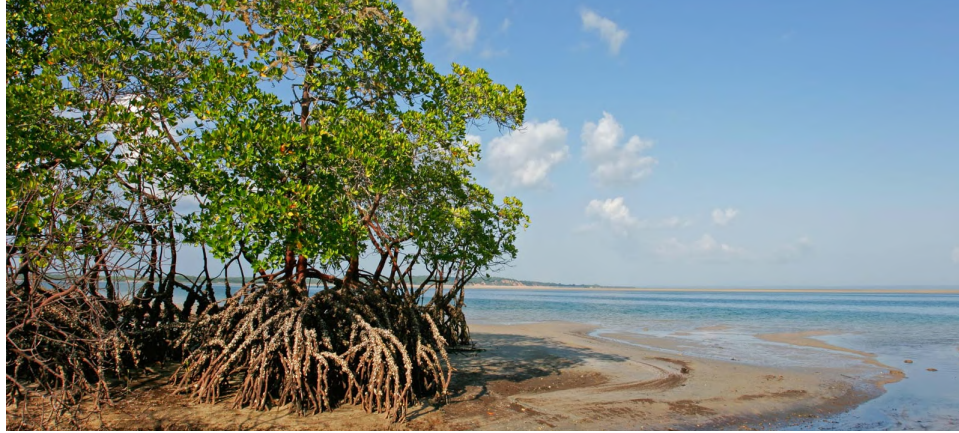
Figure 9. Red Mangroves (Britannica, 2019)

Living shorelines can take a multitude of forms (Royle, 2015), but are primarily aimed at controlling coastal erosion while preserving and enhancing natural ecosystems. The addition of mangroves along the shore has been shown to provide subsurface rigidity to help the shore maintain its structure. Mangroves also provide natural shading and nurseries for marine life and would improve the natural aesthetics of the park, while minimally reducing walkability. Aqua Engineering spoke with Dr. Hapke, and she recommended that a biodegradable coir geotextile (Figure 8) could benefit the beach by stabilizing the sand while giving time for the roots of newly planted mangroves to develop and become effective at fighting erosion (Figure 9).

fully take root. Planting mangroves is proven to fight coastal erosion without presenting any safety risks to beach goers. It is suggested that partially matured and salt-conditioned mangroves be implemented so they have the best chance of developing root structures that will be adequate to fight erosion. Aqua Engineering determined that the red mangrove propagules and juvenile plants are to be planted along the north stretch of the beach as a long-term solution. Once the roots have established themselves, the mangroves should effectively prevent scour for well over 50 years with little maintenance. For a coir geotextile liner, mangroves, and the installation and maintenance costs of each, the total is estimated to be approximately \$70,500 for an area of 0.40 acres. This is a relatively inexpensive solution, especially given the long-term beneficial impact that the implementation of this solution may have.

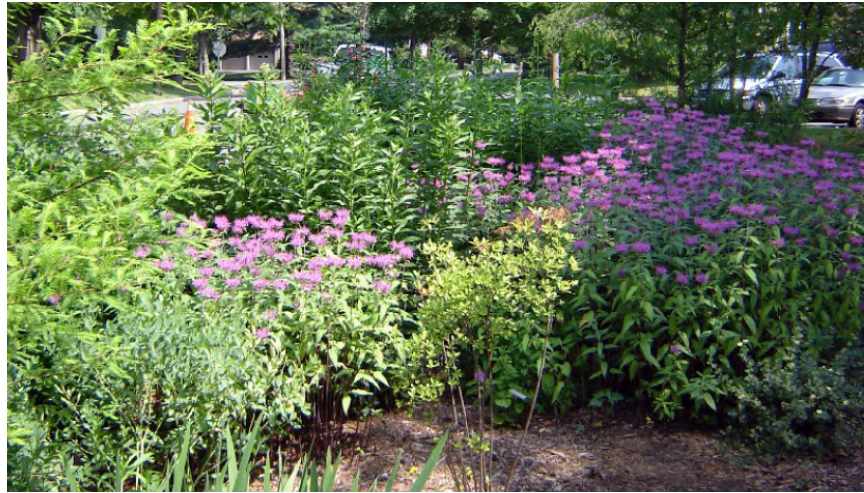
Figure 12. Bioretention Bed Example (Rutgers, 2019)

With the natural aesthetic of the park, results of the community survey, and existence of a previously planted garden at Lassing Park, it can be presumed that the frequent visitors prefer natural solutions. Because of this, Aqua Engineering proposes a bioretention bed, or rain garden, as a means of enhancing water quality while still bringing attention to the park's native beauty (Figure 12).

Bioretention gardens were implemented in the 1990's to attenuate stormwater that accumulated as a result of manmade structures (Un, 2010). The purpose is to facilitate natural processes of water drainage and filtration that impervious land prevents. Filtration, precipitation and the activity of microbes in the plant root zone (i.e., rhizosphere) help to capture, assimilate and transform nutrients, organic matter, solids, metals and FOG before they are released into receiving waters. By routing stormwater runoff through bioretention systems, plants are given time to absorb nutrients or pollutants such as nitrogen and phosphorus from the influent before it is released into collecting water bodies or systems. By holding water within the bioretention system for a predetermined amount of time, plants are able to facilitate evapotranspiration of the influent water, thus reducing the loading to the stormwater system. Plants will help treat the water, thereby improving the water quality of the effluent from the system.
